Soil Reinforcement

Syntex[®] (GHS 70/70) High Strength Geotextile - highway repair Takaka Hill, Nelson

Client: Transit NZ

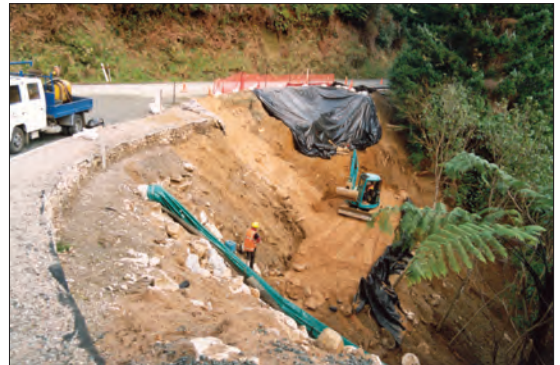
The area was first graded and smoothed, removing any rocks and debris. Two layers of AP 65 aggregate was placed using Syntex GHS 70/70 geotextiles to a depth of 150 mm. Then the first layer of Syntex GHS 35/35 geotextile was placed.

Once backfill was placed to the height required by the design (600 mm), Syntex 2x2 was laid over the compacted Onekaka Schist Sandy soil. The sequence was repeated until the wall reached its total height of 6 m.

Hydroseeding the wrapped face of the wall was suggested and a row of Poplar Poles was placed at the base to give additional protection from the UV exposure to the wrap around geotextile face.

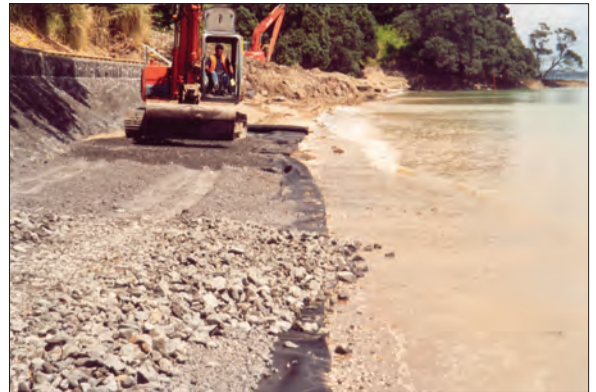
Placement of the geotextile was made after the area was cleared and was placed directly over the sandy soil. 50 mm of GAP 40 fill was then placed over the geotextile and overlaid with 350 mm of GAP 100 using an 8 tonne digger. The result is that the site subgrade was successfully stabilised which allowed the movement of 22 Tonne trucks on this access road to do slip repair work.

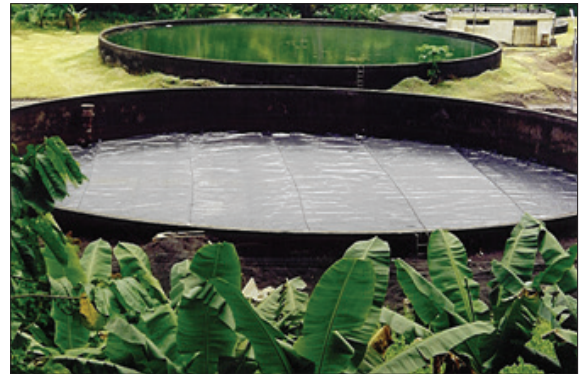
For rehabilitation of the filters, it was suggested by engineers to remove sand and wash it and prevent further infiltration of fine silt material into the lower gravel layers. To achieve this, Syntex GHS 35/35 high strength woven geotextile was recommended to be placed on top of the gravel layer because of its high strength and superior hydraulic properties.

Syntex GHS is manufactured in an ISO 9001 facility and tested by a GRI (Geosynthetics Research Institute) laboratory. In total, five Syntex sand filters of 28 meter diameter each were fabricated by Permathene Ltd in Auckland and installed at Alaoa treatment plant in Apia to prevent sand particles of < 0.15 mm infiltrating into the bottom gravel layer of the water treatment plant.
